DOT/FAA/RD-94/22

①
**Composite Helicopter
Accident Profiles -
Deficient Crew/Aircraft
Performance**

Final Report

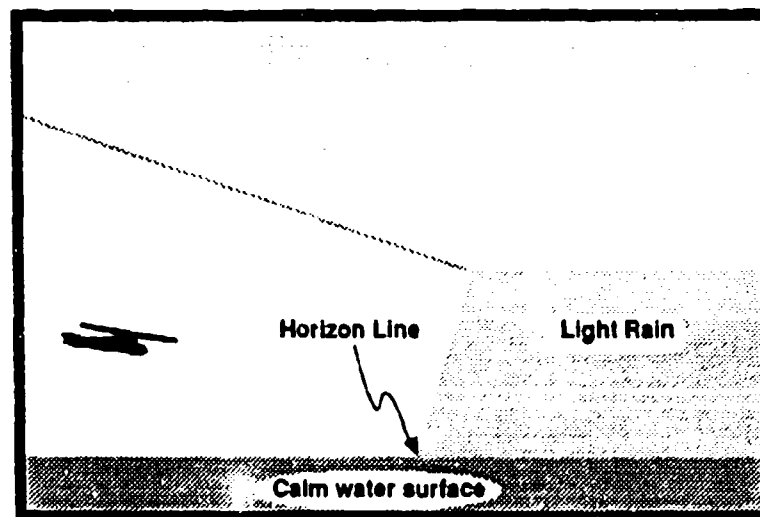
FIGURE 3-1. THE SURFACE PROVIDES THE HORIZON LINE REFERENCE

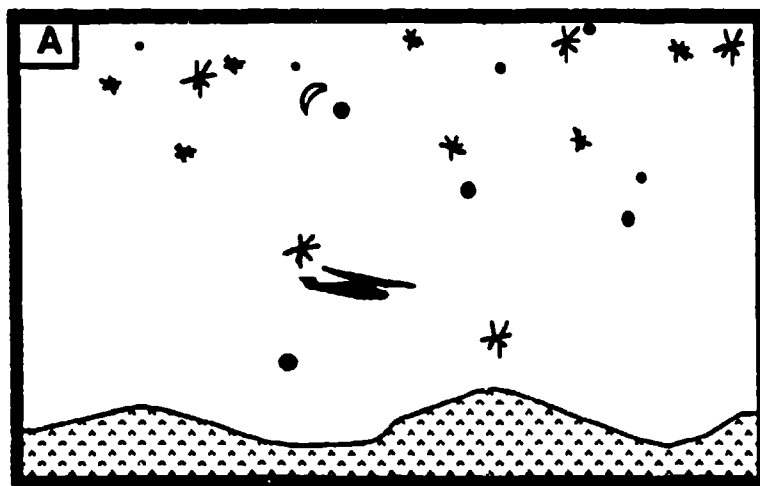
BRIGHT MOON
BRIGHT STARLIGHT
CLEAR
UNLIMITED VISIBILITY
DIM SURFACE ILLUMINATION
POOR DEPTH PERCEPTION
GOOD HORIZON

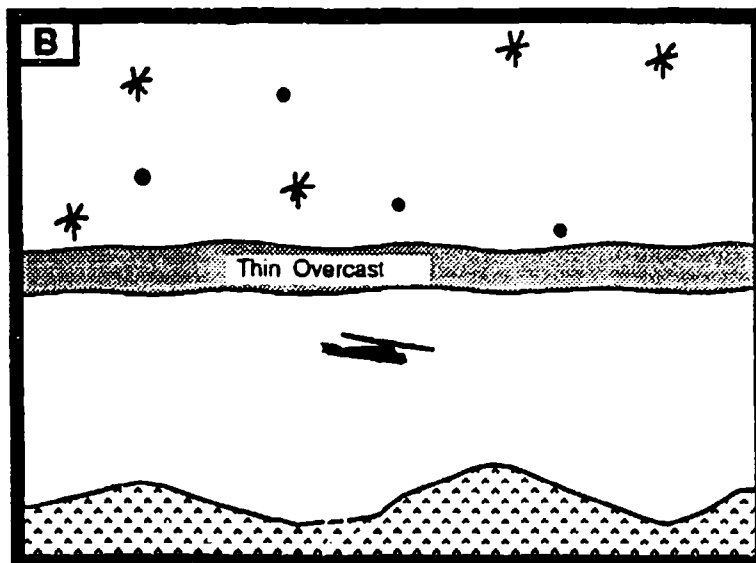
BRIGHT MOON
BRIGHT STARLIGHT
ABOVE THIN OVERCAST
UNLIMITED VISIBILITY BELOW
OVERCAST
NO SURFACE ILLUMINATION
NO DEPTH PERCEPTION
GOOD HORIZON

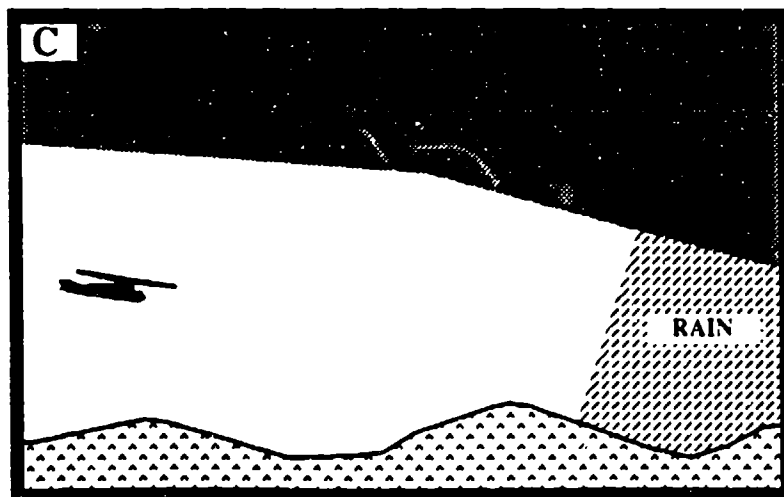
**NO HORIZON, NO VERTICAL
REFERENCE**

LOW, THICK OVERCAST

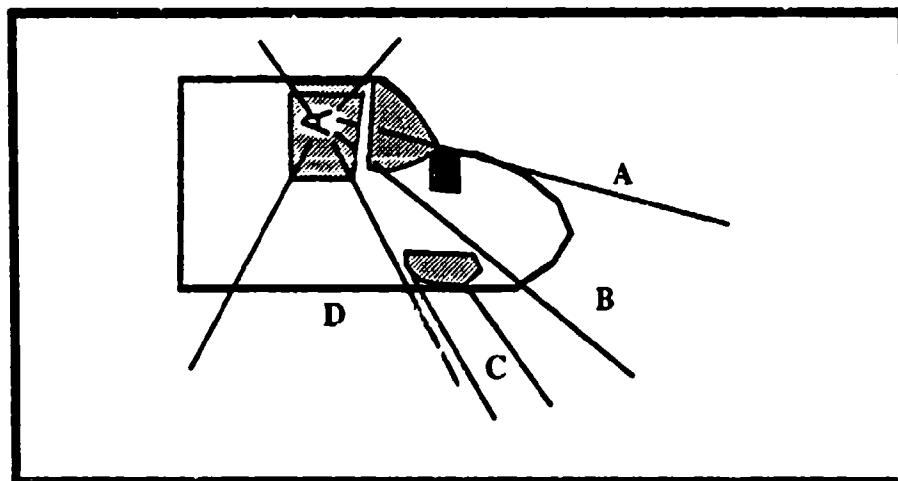
When aircraft becomes very large (over 30,000 pounds), the structure ahead and to the side of the pilots station may introduce new and different impediments to the pilot's ability to see out. Most importantly, the dimensions of a large cockpits can restrict the cross cockpit visibility of a single pilot.

FIGURE 3-5. PILOT VISIBILITY DOWN AND TO THE RIGHT FROM THE RIGHT SEAT

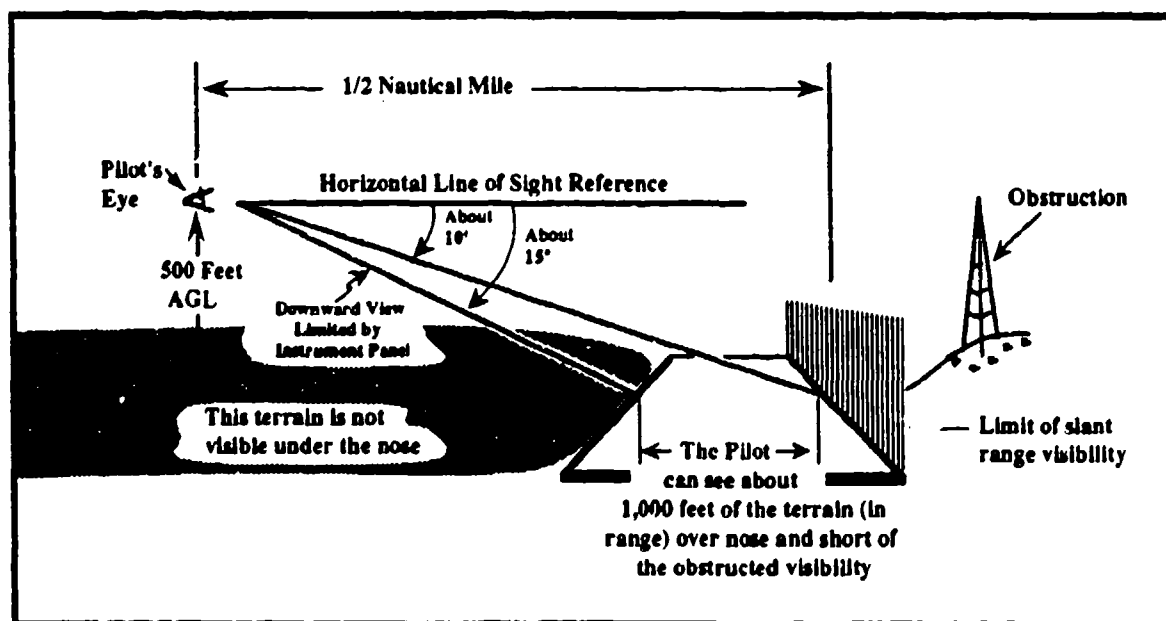
Pilots can normally expect to have a clear look-down angle over the nose of at least 15 degrees during forward flight. If this is the case and the pilot maintains 500 feet AGL over a level surface, surface features approaching the aircraft will disappear from the pilot's view (under the nose) at a point about 2,000 feet ahead of the aircraft. When forward visibility is 1/2 NM, surface features are exposed to the pilot's field-of-view for about 1,000 feet (see figure 3-6). This 1,000 foot deep view of the terrain ahead should be consistently available over a 60 to 90 degree horizontal field of regard. On first analysis, this seems to provide a reasonable daylight field-of-view to sustain VFR operations when operating at speed up to but not greater than 100 knots ground speed.

FIGURE 3-6: A CHARACTERIZATION OF THE FACTORS INVOLVED IN SEE-AND-AVOID HELICOPTER OPERATIONS

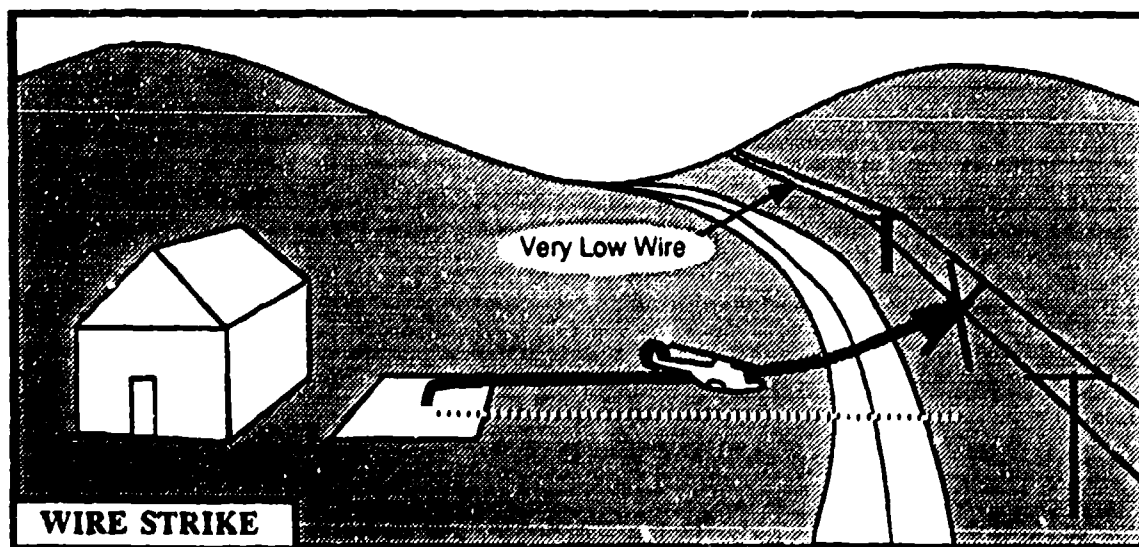
The pilot entered his aircraft to conduct a takeoff under temperature and gross weight conditions which were within normal operating limits as determined by a power margin check conducted during a low in ground effect (IGE) hover. The pilot proceeded to depart straight ahead with the intent of flying over wires which lay across the departure path. This was a routine maneuver accomplished daily. The aircraft struck the wires. No engine power degradation was observed. The aircraft just did not clear the obstruction (see figure 5-1) because of inadequate power for the situation.

FIGURE 5-1. IGE TAKEOFF INTO WIRE AS THE RESULT OF INADEQUATE POWER AVAILABLE

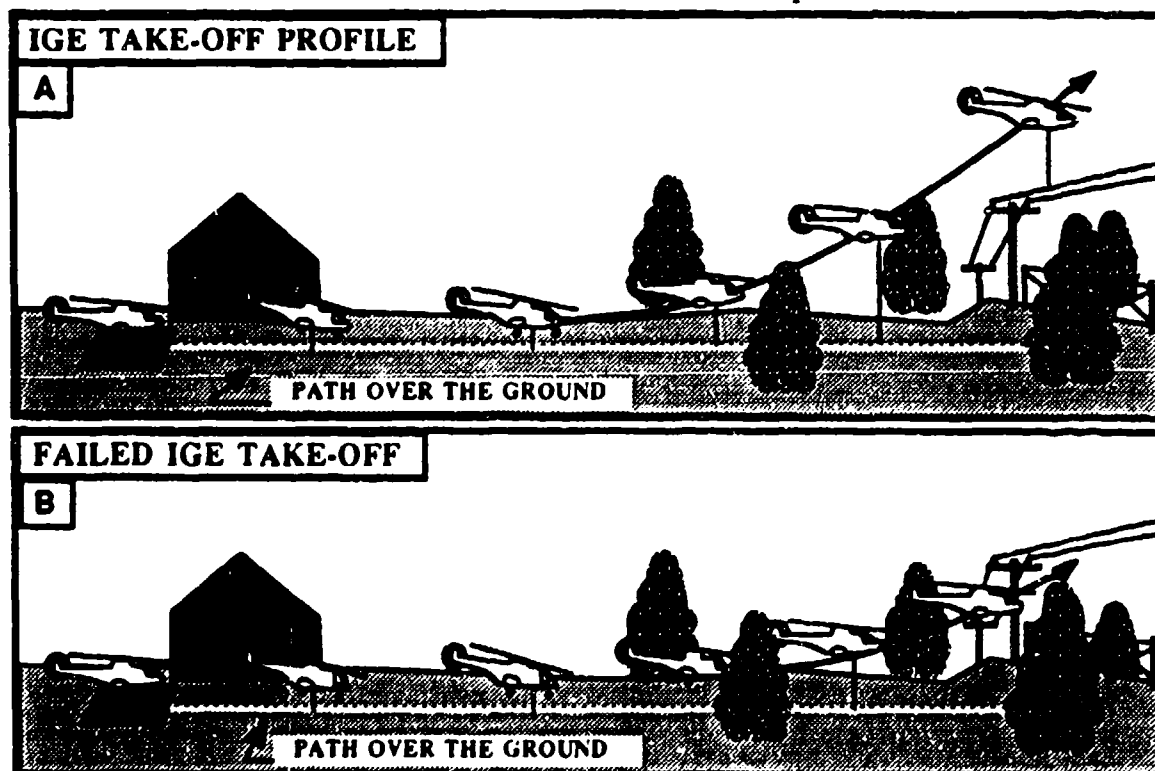
FIGURE 5-2. COMPARING IGE TAKEOFF PROFILES

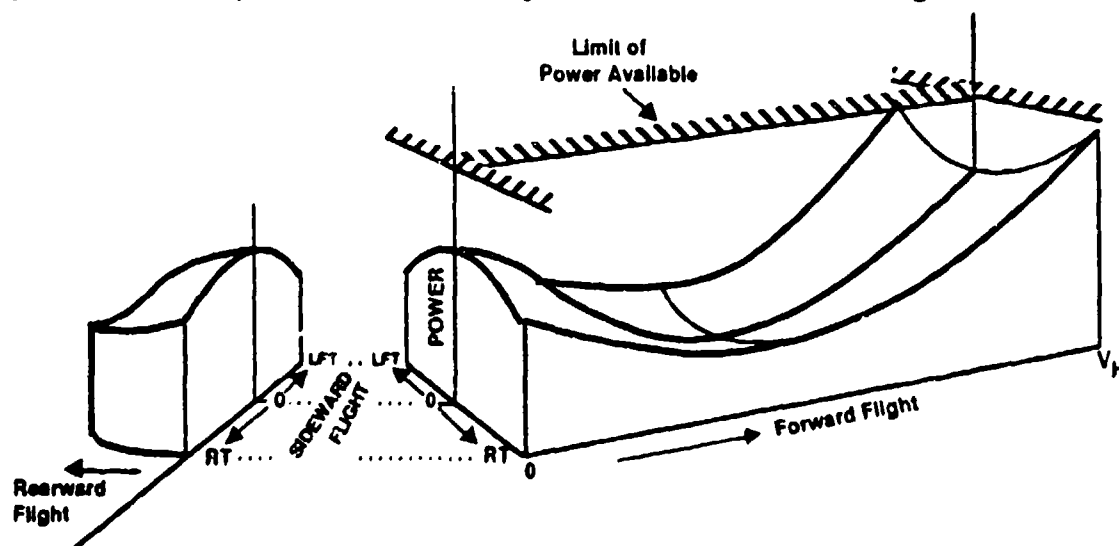
The recognition of the three dimensional aspect of power required is a step in the right direction, but the concept is not supported by sufficient data or analysis to support conclusive explanations of takeoff accidents. Until suitable helicopter performance data are collected for a matrix of omni-directional wind conditions (for analysis), a completely convincing argument will not be possible. Similarly, a satisfactory analysis of cross wind takeoff performance is beyond the scope of this study, but it is a subject which can be explored in more detail during follow-on efforts.

FIGURE 5-3 THREE DIMENSIONAL CHARACTERIZATION OF OMNI-DIRECTIONAL POWER REQUIRED FOR A SINGLE ROTOR HELICOPTER

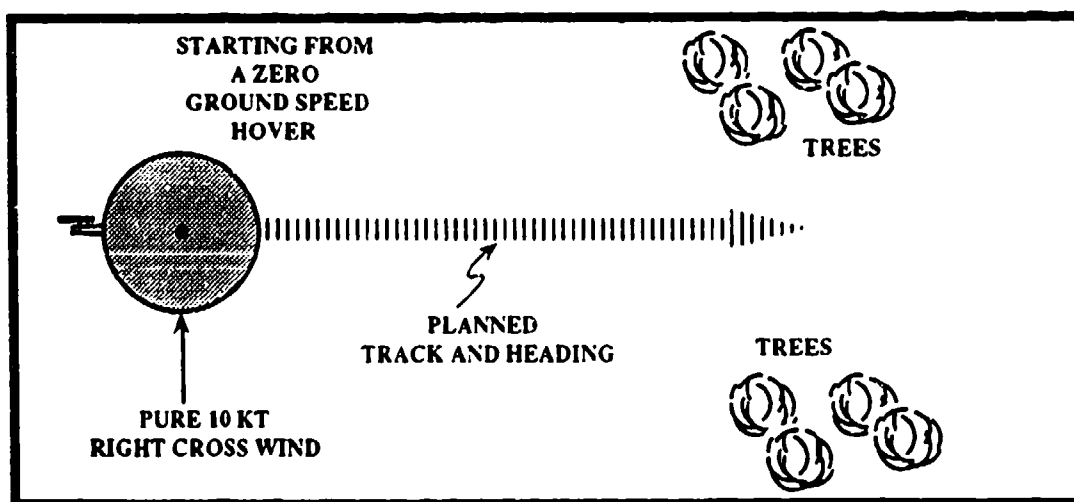
The takeoff follows a singular path regardless of the wind line. It follows a straight line over the ground (and it does not involve a crab in the presence of a cross wind). Assume that this takeoff is conducted so as to pass safely between obstructions prior to reaching the barrier obstruction which the helicopter is expected to fly over (see figure 5-4). The pilot keeps the wheels (skids) aligned with the IGE track to insure that a power loss (or pilot inattention) causing the aircraft to touch down will not result in a roll-over crash.

FIGURE 5-4. HIGH PERFORMANCE (IGE) TAKEOFFS ARE STRAIGHT-AHEAD

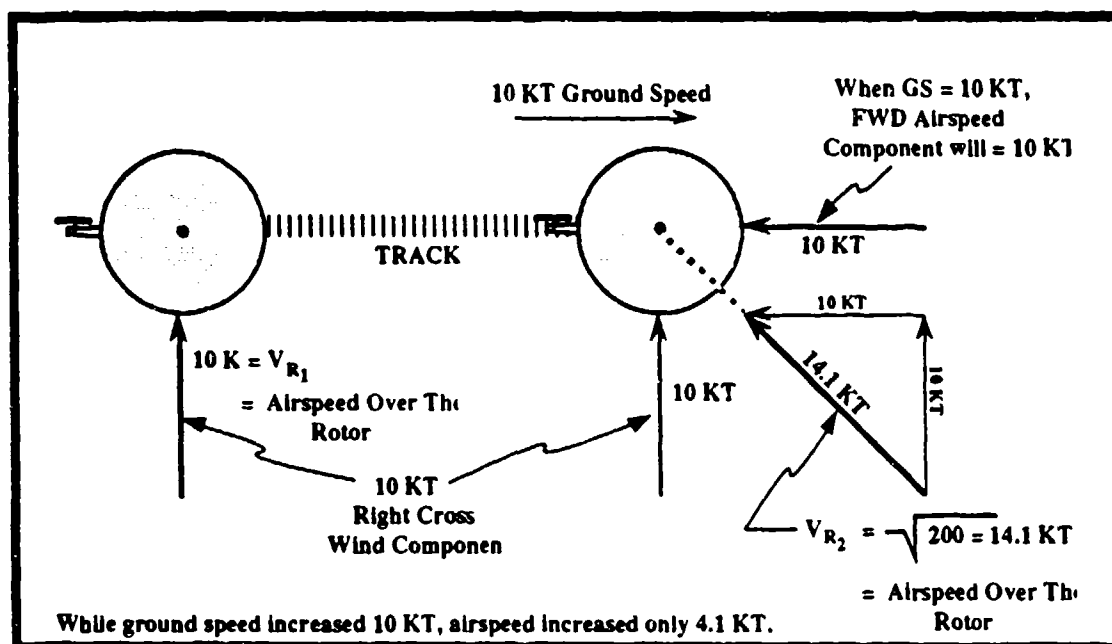
The airspeed indicator may provide a useful performance cue in some aircraft but it is unreliable in most helicopters below 30 or 40 knots, especially in ground effect. In any event, ground speed provides the predominate speed cue during this maneuver, but power required is an airspeed dependent parameter and this may be a significant problem during a confined area takeoff in a cross wind.

FIGURE 5-5. RELATIVE WIND CHANGE DURING TAKEOFF IN A CROSS WIND

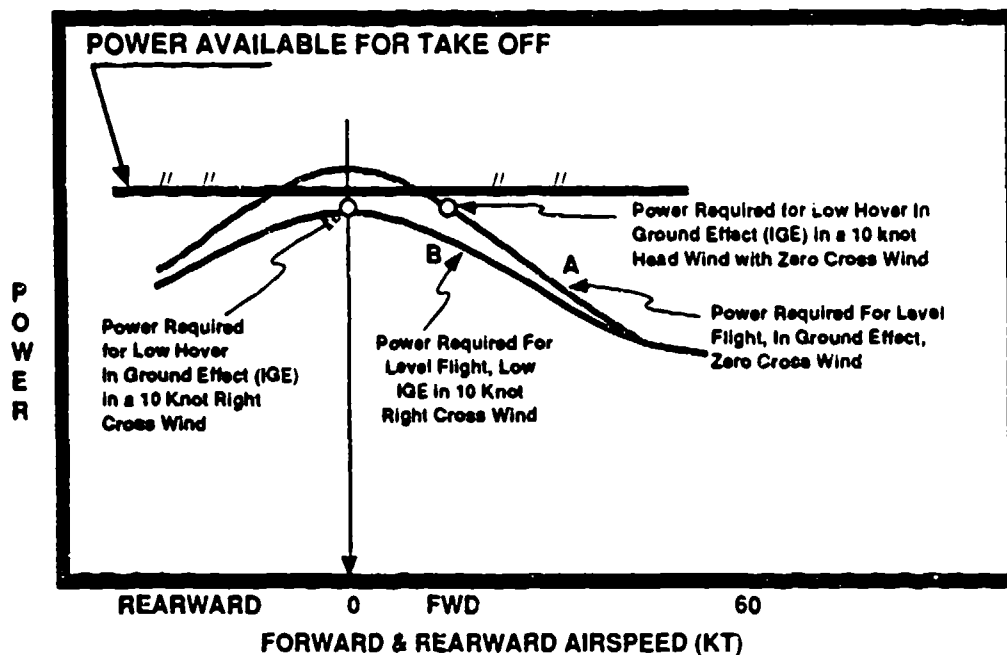
An additional problem may develop in the tailrotor at about the same time the aircraft reaches 10 knots ground speed. That is, the angle of the relative wind may cause the trailing vortex of the main rotor to interfere with the tailrotor. This will increase the total power required (as discussed above). This main rotor to tailrotor interference can also increase the pilot's workload in yaw control and momentarily distract the pilot, with a resultant degradation in takeoff control technique. This inattention may cause the pilot to prematurely fly up and out of low IGE flight, adding another increment of the power required and decreasing the margin for acceleration and climb.

FIGURE 5-6. POWER REQUIRED IN GROUND EFFECT

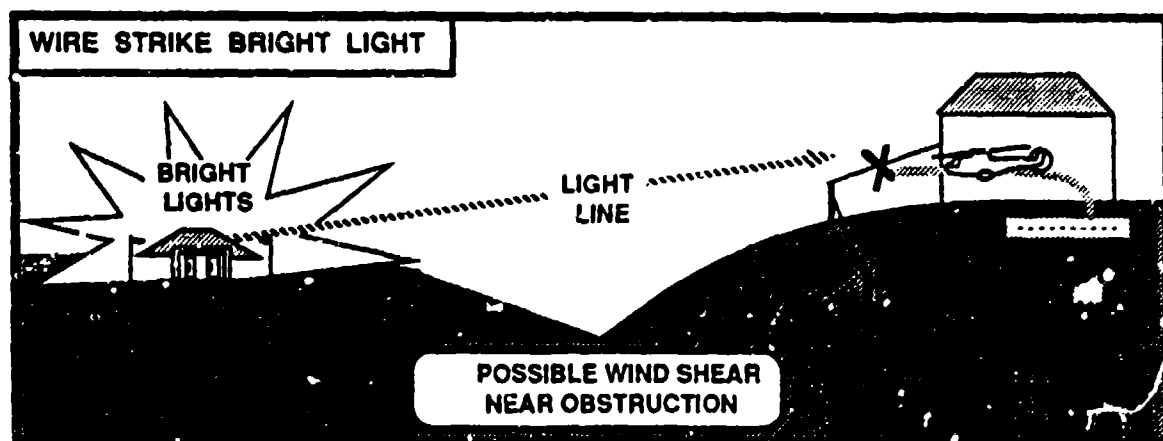
The presence of a light as shown in figure 5-7 may have had two effects. A light so located could have made it more difficult to see the wire. In addition, if the lighted area was substantially below the takeoff area, and the remaining area was very dark, the pilot may have been misled as to the horizon reference. Since the takeoff is a heads-out, eyes out event and the pilot would not reference the altitude indicator to select the acceleration altitude, he would then look outside and use the reference found there. If the reference available provided the pilot with a depressed horizon line (below the earth horizon), the pilot may have been induced to over rotate (nose down) during the initial departure acceleration. Having over rotated, there may have been insufficient power to climb out over the wire, and too little room (or time) to flare and stop.

FIGURE 5-7. VERTICAL TAKEOFF INTO WIRE FROM HELIPORT

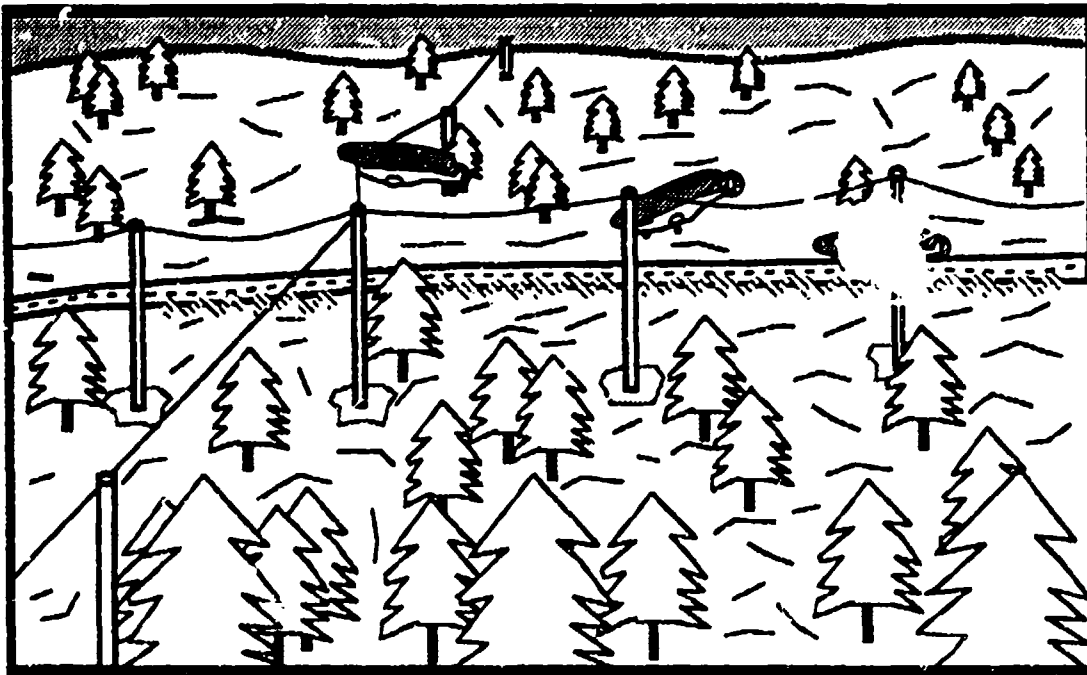
The pilot knows that when the nose comes up and the aircraft climbs away from the ground, the visual cues available for flight path management will suddenly diminish to almost nothing. If the departure is into white (auto) lights, or if a landing light is used for takeoff, a finite period of time is required for the pilot's eyes to adapt to the dark night visual cue system.

FIGURE 5-8. NIGHT TAKEOFF INTO WIRE

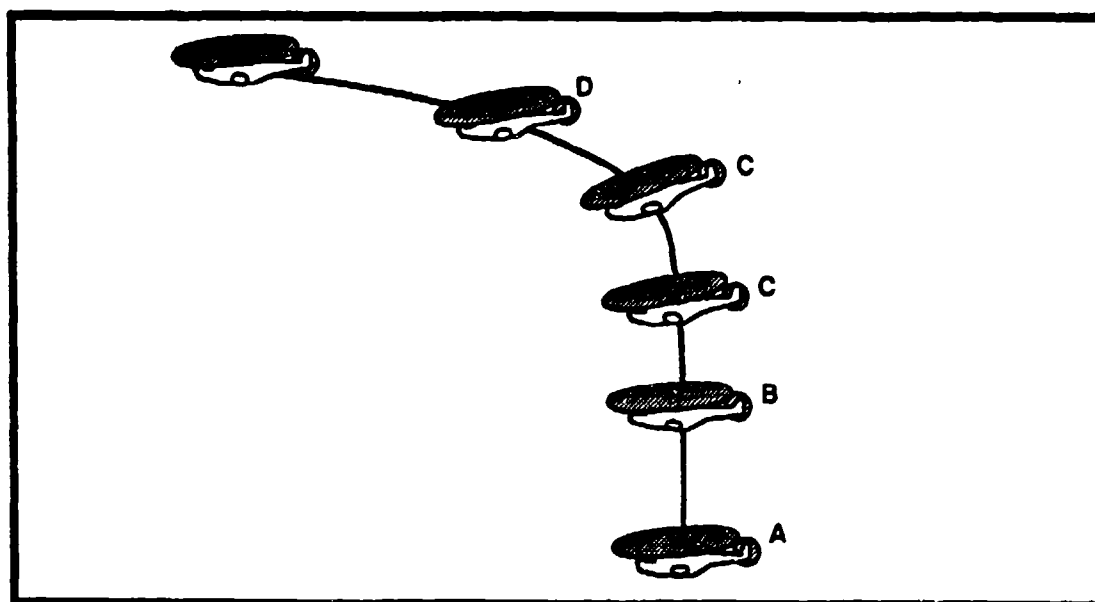
With a vertical rate established, the pilot gradually depresses the nose attitude and the aircraft starts to accelerate while climbing. The success of this departure is dependent upon power, good slow speed flying qualities, and good cockpit displays. A radar altimeter would be a great aid during the initial minutes of the departure. When compared to the running takeoff, the vertical departure also provides a more acceptable visual transition.

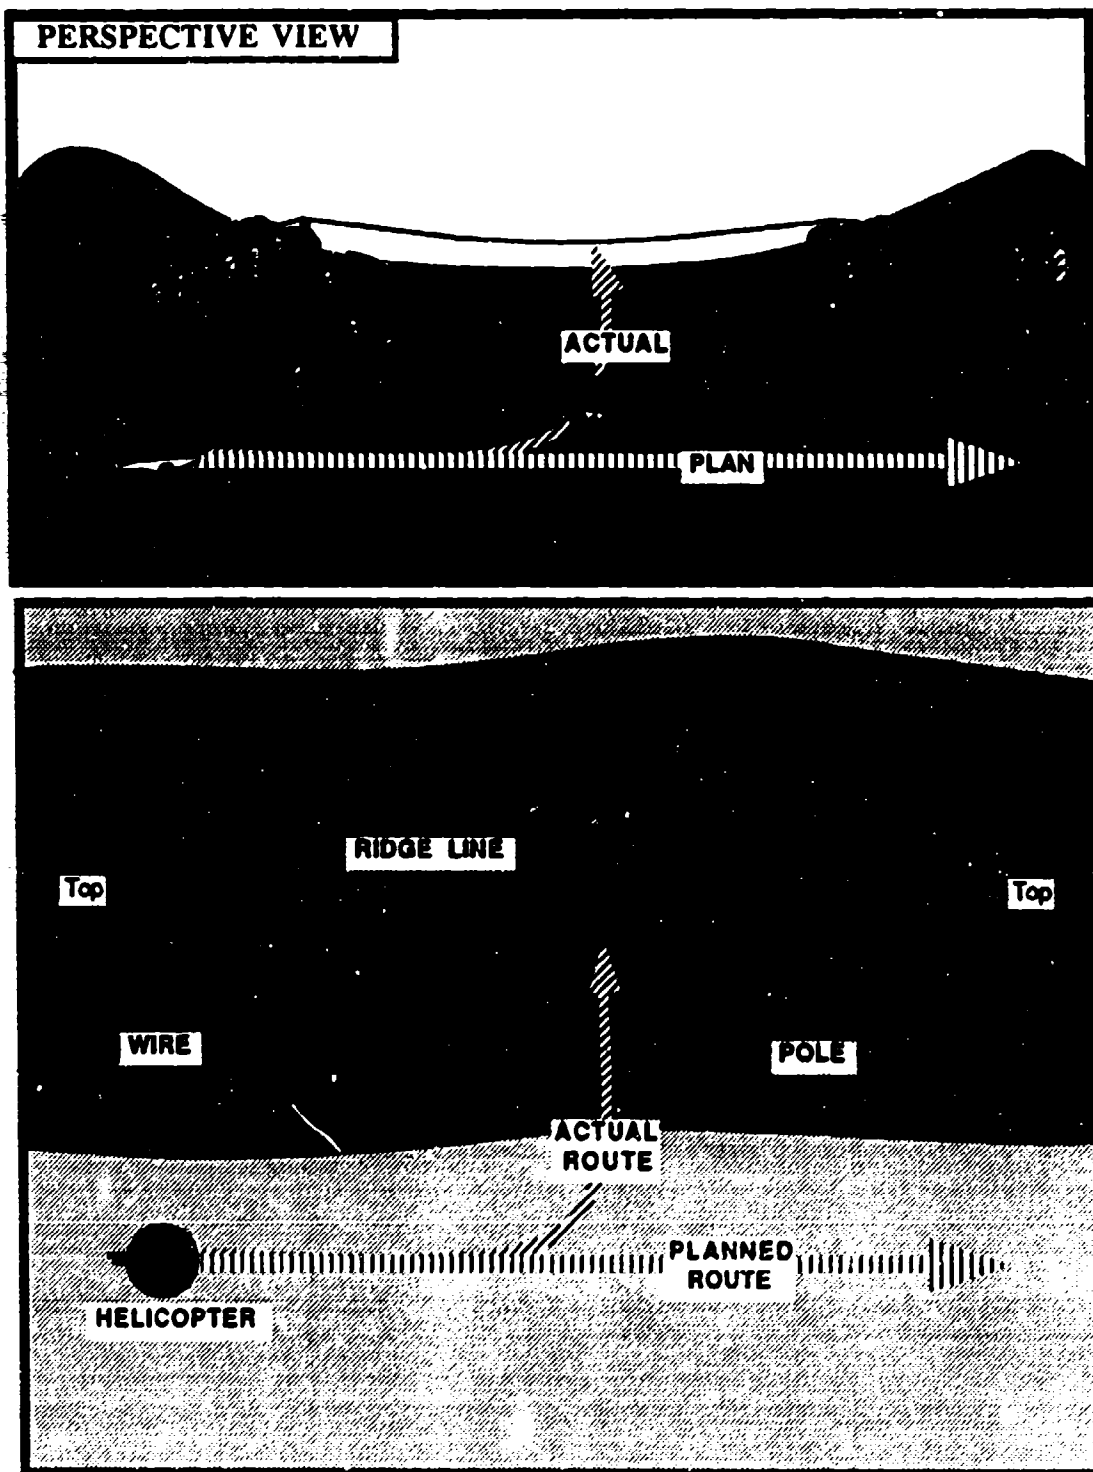
The need to climb motivated the pilot to slow down to the speed for best rate of climb (to improve climb performance). The decelerating flare undoubtedly produced a

FIGURE 6-1. CLEAR DAY, RIDGE LINE WIRE STRIKE

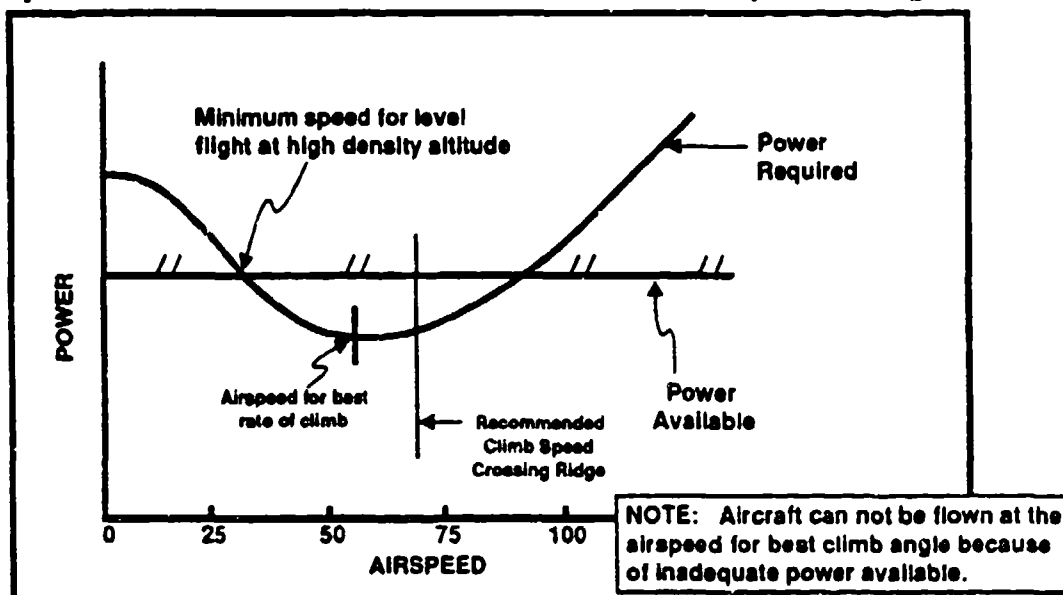
maneuvers or to egress from a down draft (common in mountain operations). If the pilot slows too much, the rate of climb may drop dramatically. For example, if the pilot slows below the minimum airspeed for level flight (figure 6-2), the aircraft will descend. Had the pilot maintained a climb speed which was even slightly higher than the speed for best rate of climb, the pilot would have been in position to trade airspeed for a 180 degree turn (to retreat away from the ridge in case of a problem) or to conduct a pull-up maneuver (to clear an obstruction detected at very short range).

FIGURE 6-2. INSUFFICIENT POWER FOR ROBUST VERTICAL AGILITY

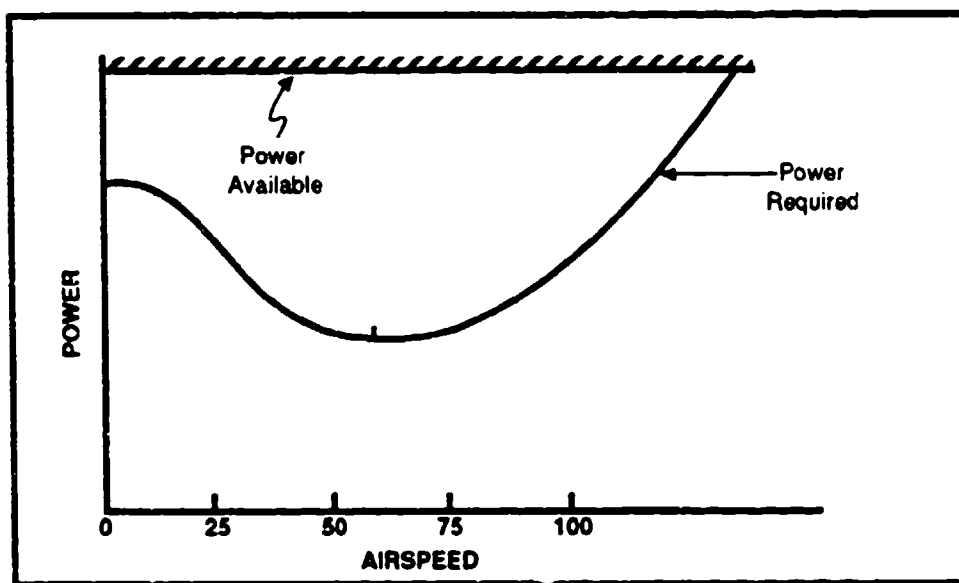
Large power margins are required to achieve good slow speed vertical agility (see figure 6-3). Pulling up on the collective commands an instantaneous vertical acceleration and if the power commanded does not exceed the power available, the rotor speed will normally stay in the safe region. Quick pull-ups (flares) from 60 to 30 knots will also provide a very useful (additional) transient climb, further increasing vertical agility. An aircraft with the performance margins depicted in figure 6-3 exhibits robust vertical agility and will climb well even if the aircraft is slowed to 30 knots.

FIGURE 6-3. AMPLE POWER FOR ROBUST VERTICAL AGILITY

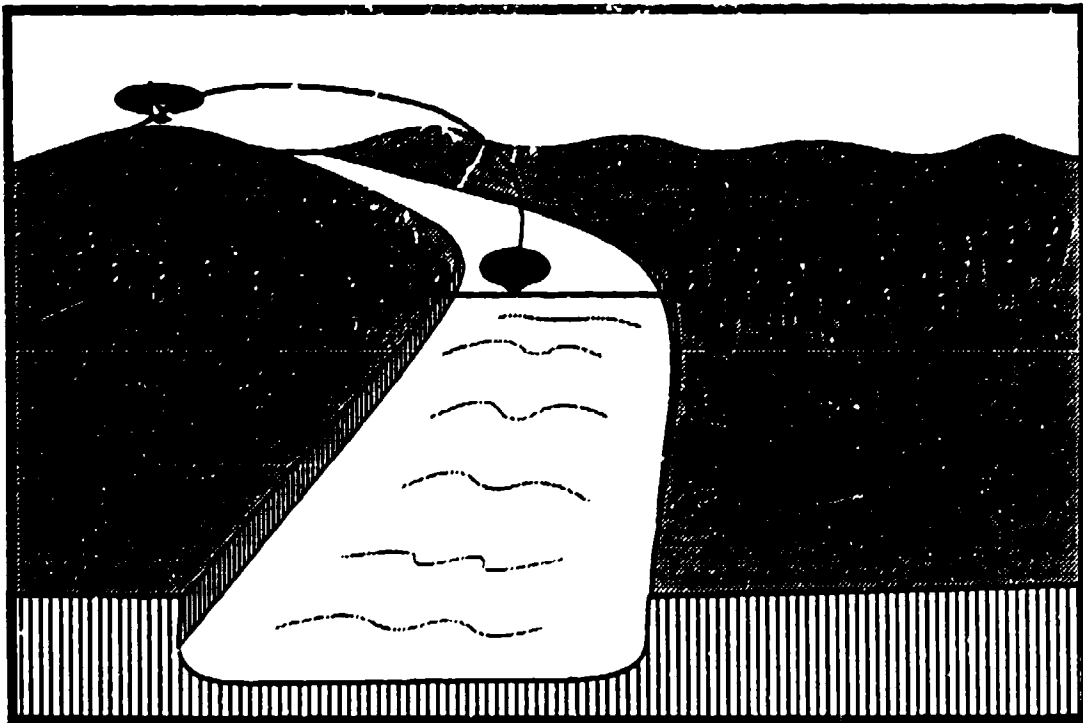
It would appear that situations like this one make a strong argument for increased verticality during approaches to unfamiliar terrain. Failing this solution, wire cutters should be installed on aircraft required to enter this environment on a regular basis.

FIGURE 6-4. FAULTY RECONNAISSANCE

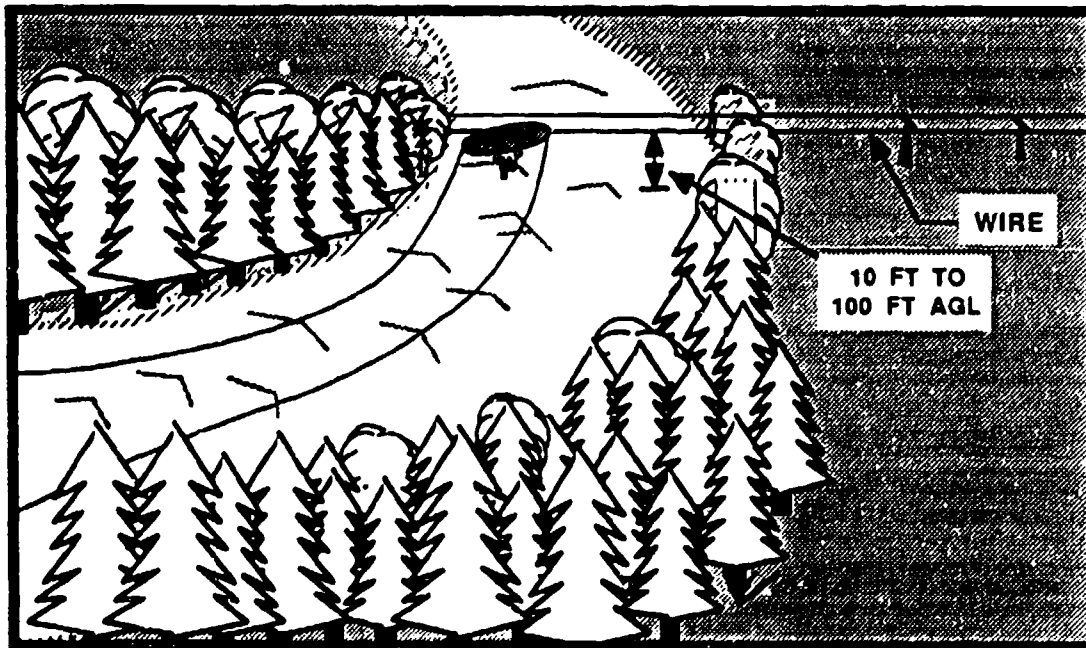
In summary, there is generally no valid mission oriented reason for very low altitude operations along roads or rivers. Thus, such operations appear to represent reckless disregard for flight safety.

FIGURE 6-5. RECKLESS RIVER FOLLOWING OPERATIONS

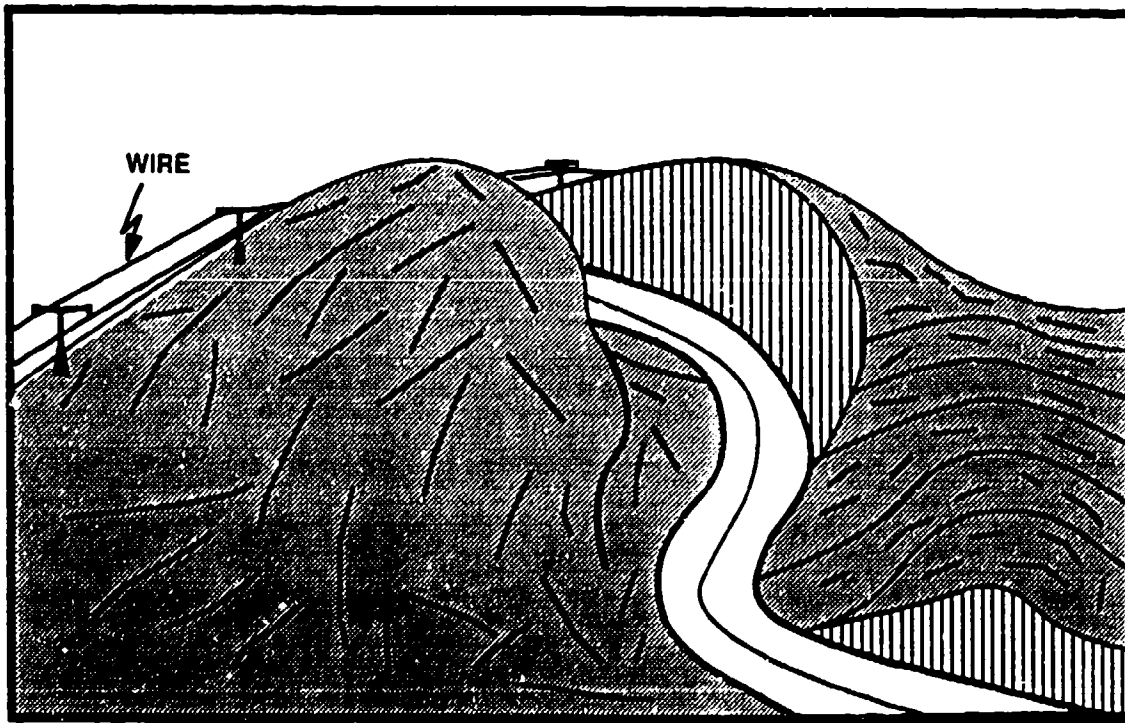
FIGURE 6-6. RECKLESS ROAD FOLLOWING OPERATIONS

- 1) Never fly below 200 feet AGL while following a road or river bank, even if the area is well known.
- 2) If it is essential to enter a depression which may involve wires that are difficult to detect, approach the area from several directions to take advantage of lighting and terrain background which may aid wire (or wire support) detection. When possible use verticality in the approach.
- 3) Pilots should develop a thorough understanding of the power required curve and learn to avoid flying into situations which may induce them to flare and decelerate to the backside of the power required curve while in proximity to terrain which may require robust vertical agility.
- 4) Pilots should never approach a ridge line without sufficient speed and altitude to clear the ridge by hundreds of feet.

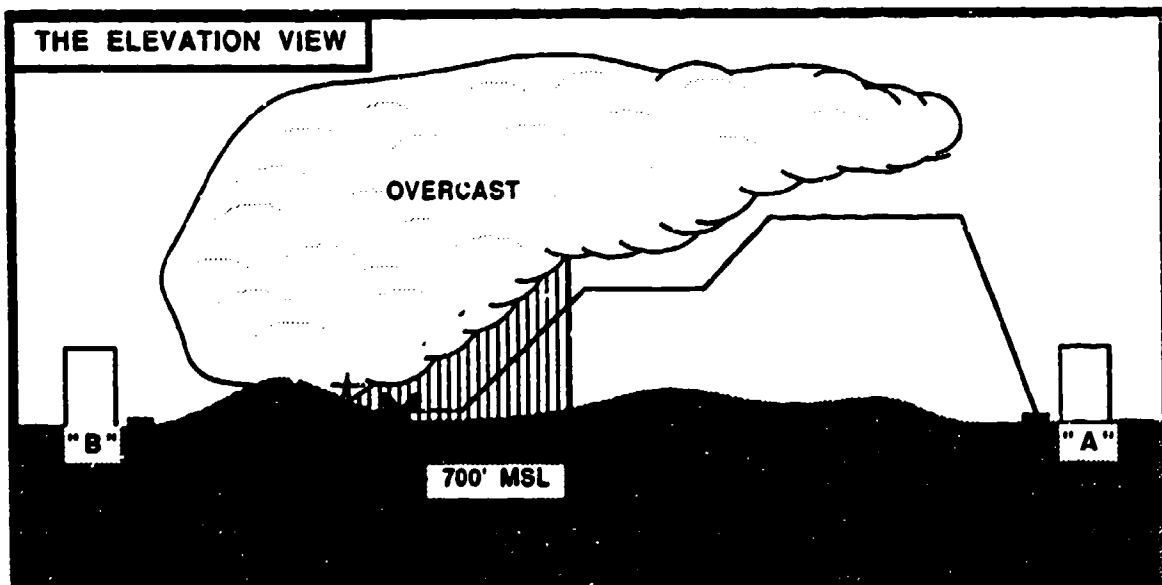
The pilot departed one hospital for another under apparently satisfactory weather conditions and intended to go direct using electronic navigation means. Shortly after the flight commenced, the pilot determined he was not going to be able to fly direct as originally planned (figure 7-1). Instead he elected to follow a highway. Subsequently, the visibility along the newly selected route became less and less acceptable. Eventually the pilot determined that the weather situation was not going support continued flight along the highway, and the pilot decided to turn around and return to the point of departure. At this point, the aircraft was flying no faster than 90 knots.

FIGURE 7-1. TYPICAL EN ROUTE FLIGHT PROFILE

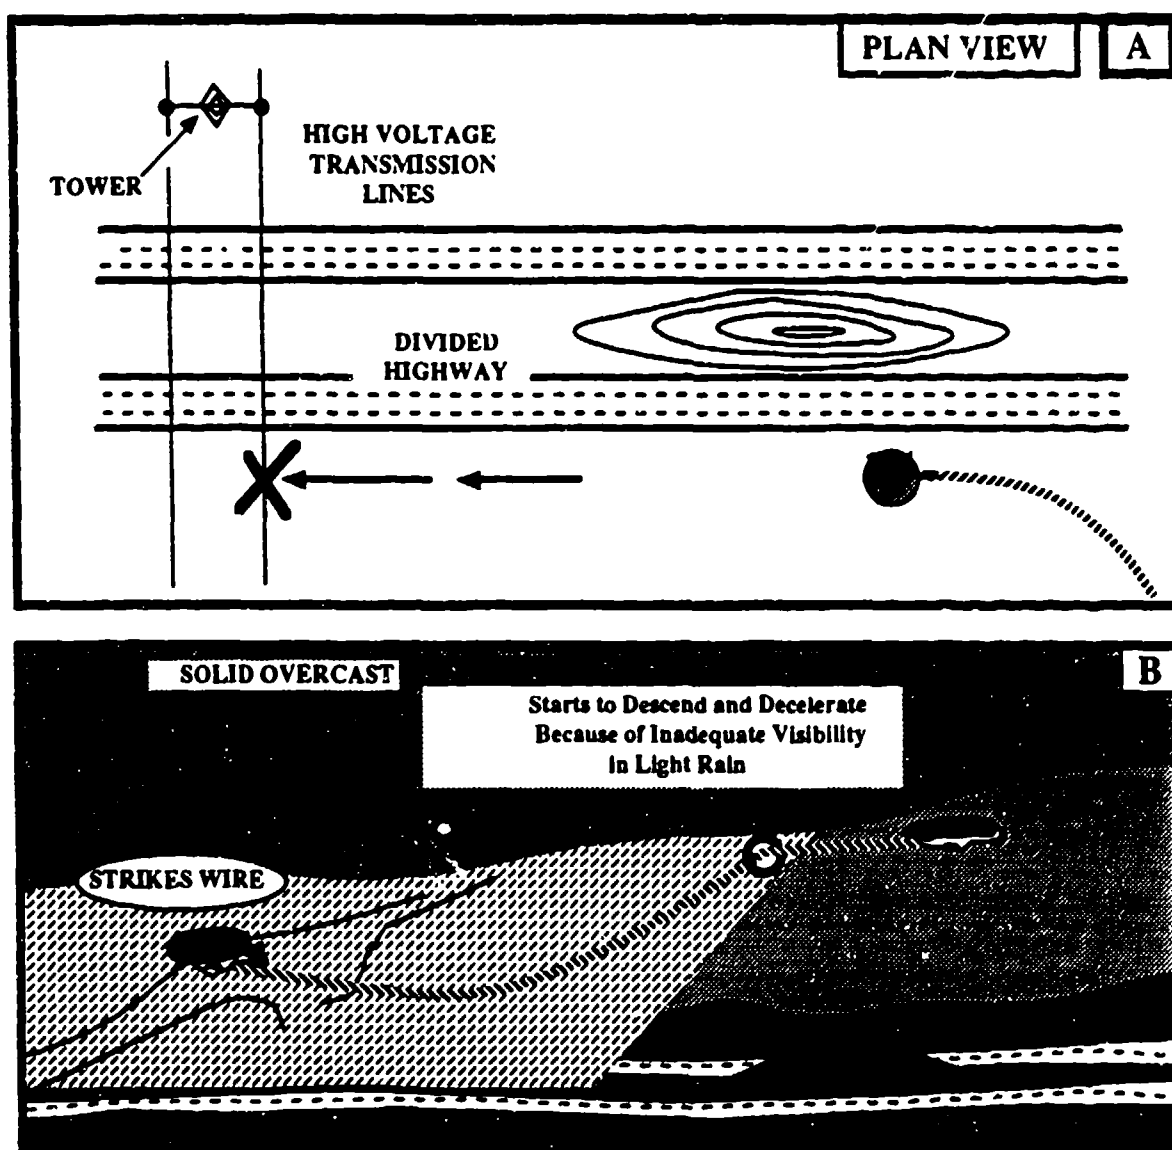
This aircraft was flying too low to start with and probably lost altitude during the deceleration (figure 7-2B). The pilot was probably attempting to retain a forward visual scan to look for obstructions. The pilot may have lowered the collective too much during the flared deceleration and inadvertently descended.

FIGURE 7-2. HIGHWAY FOLLOWING WIRE STRIKE

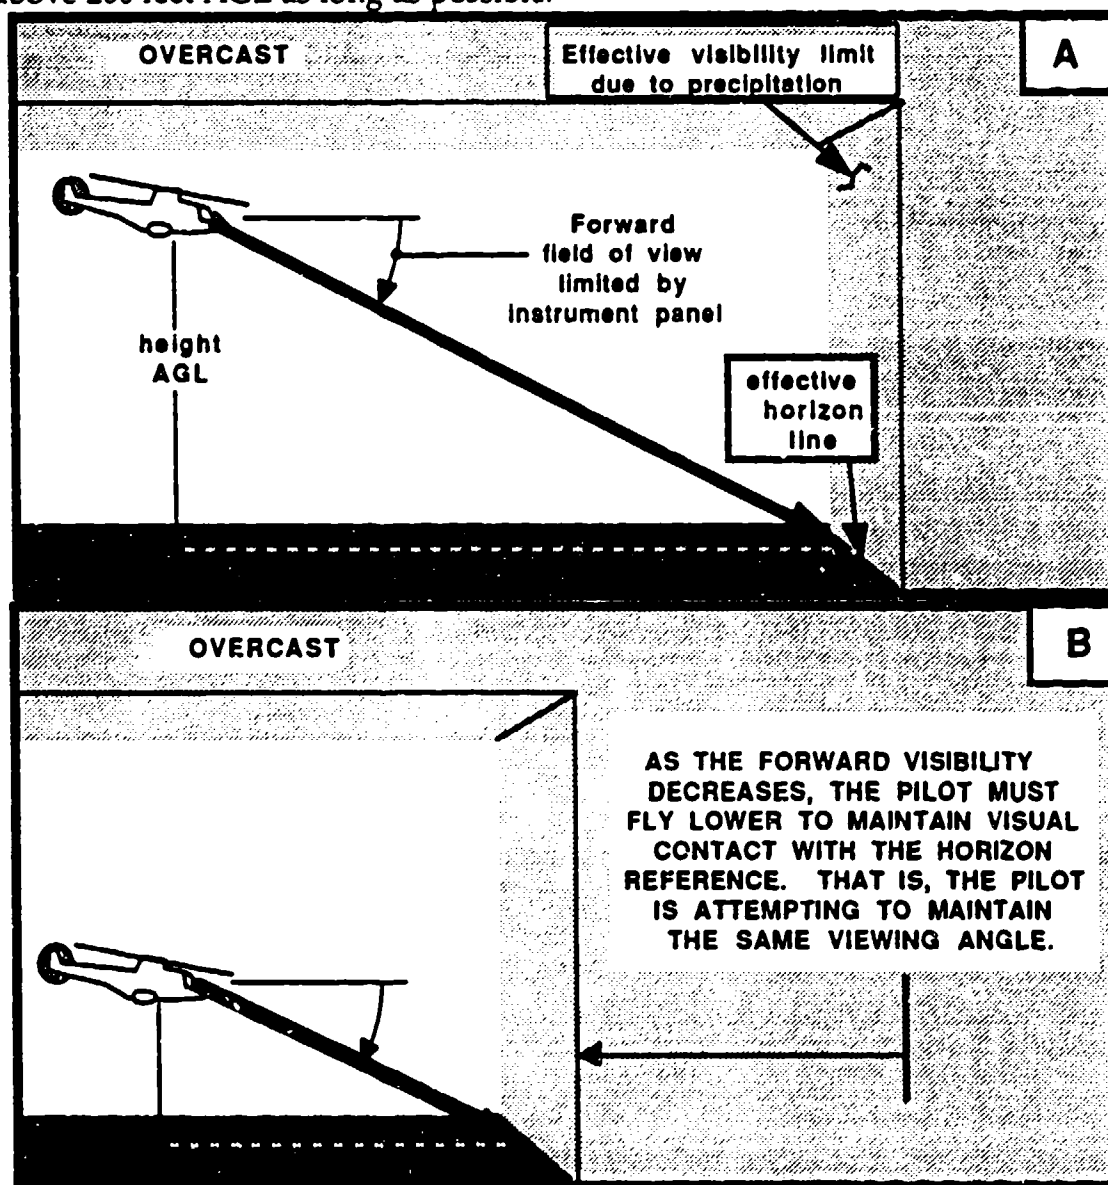
When a pilot encounters decreasing ceilings or decreasing visibility, the natural reaction is to descend. Figure 7-3 illustrates the effect of decreasing visibility; this is the factor which is underappreciated. If the visual range decreases to roughly 1,000 feet, the pilot of most helicopters will probably have descended to about 300 feet AGL, maybe lower. Concern for wires crossing a road will typically cause a prudent pilot to stay above 200 feet AGL as long as possible.

FIGURE 7-3. SHORTENED VISIBILITY DICTATES LOWER OPERATING ALTITUDES

- (1) When a pilot is just able to see the terrain over the nose (as shown in figure 7-3A), the visual range is roughly three times the pilot's altitude above the surface.
- (2) A typical helicopter requires a distance to stop (in feet) which is equal to twenty times its speed (in knots). That is a 60 knot aircraft requires 1200 feet to stop.

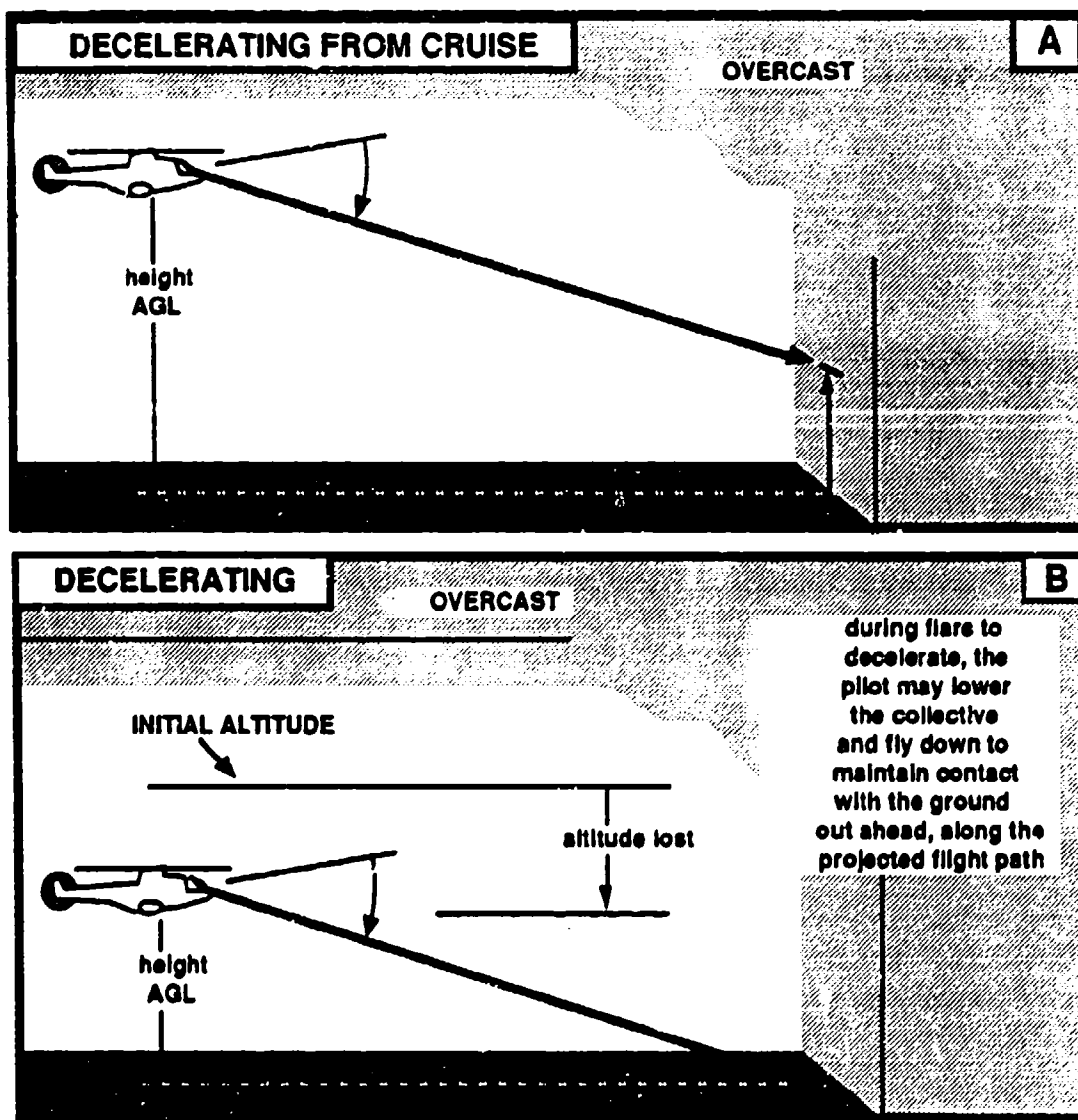
FIGURE 7-4. PILOTS WILL FLY LOWER TO RE-ESTABLISH CONTACT WITH THE TERRAIN AHEAD

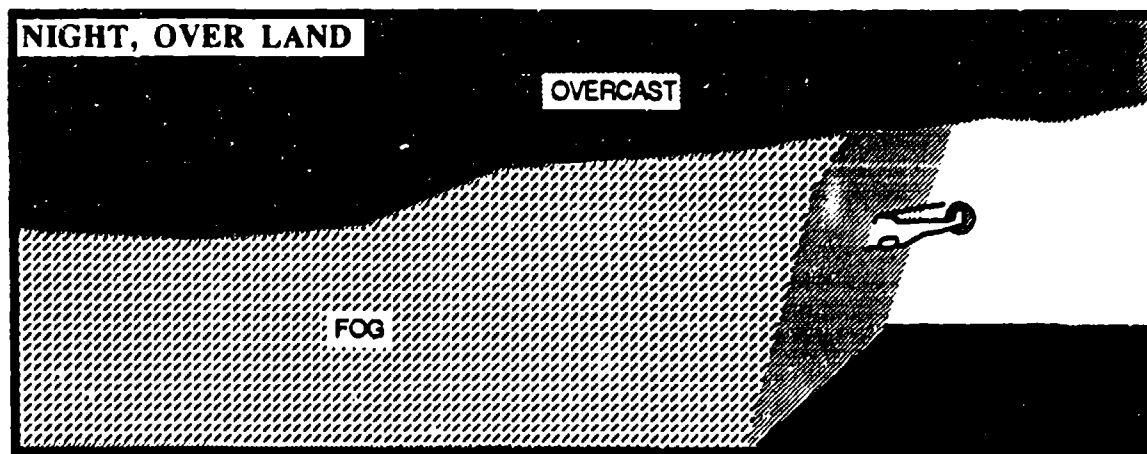
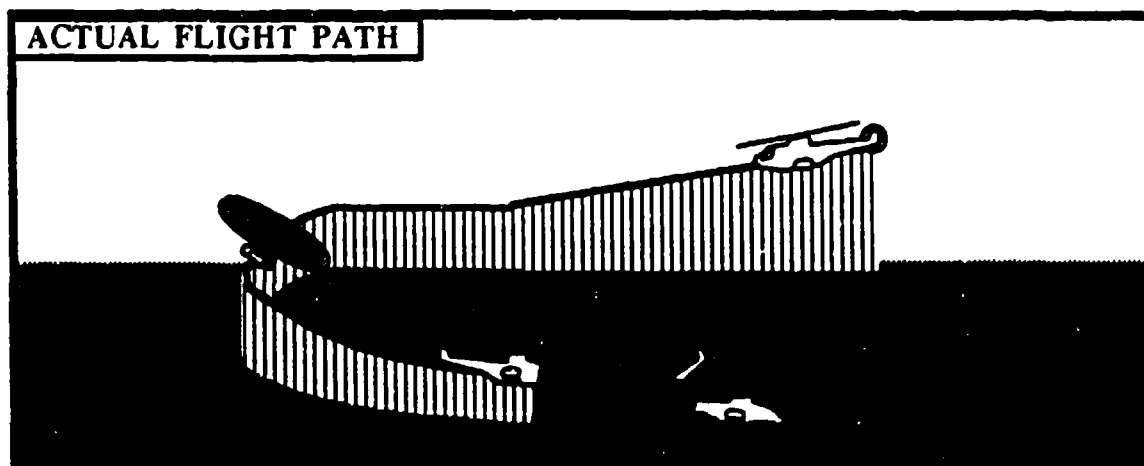
As noted earlier, a sudden reduction in visibility will often cause pilots to slow down, descend, and turn to egress. In this case, the aircraft was slowed to the point of operating on the back side of the power required curve. This meant that the power setting selected by the pilot for level flight was probably insufficient (see scenario 7-C).

FIGURE 7-5. ATTEMPT TO EGRESS FROM A SUDDEN DECREASE IN FORWARD VISIBILITY
